28th April 2018 Boxmoor Kiln Log

Kiln log

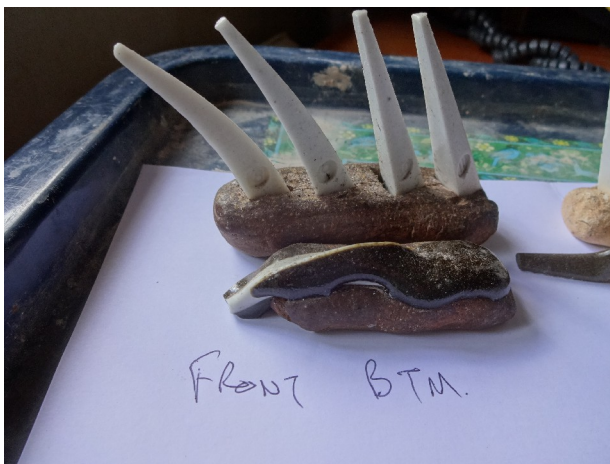
Front Btm shows cones 06/2/5 collapsed at front and cone 8 with sag and cone 9 with slight movement at rear, cones 10/11 no movement

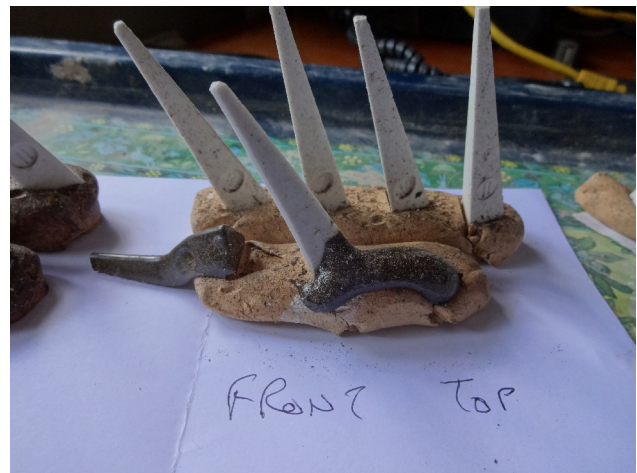
Front Top shows cones 06/2 collapsed at front with cone 5 having slight sag. Cones 8/9/10/11 having no movement.

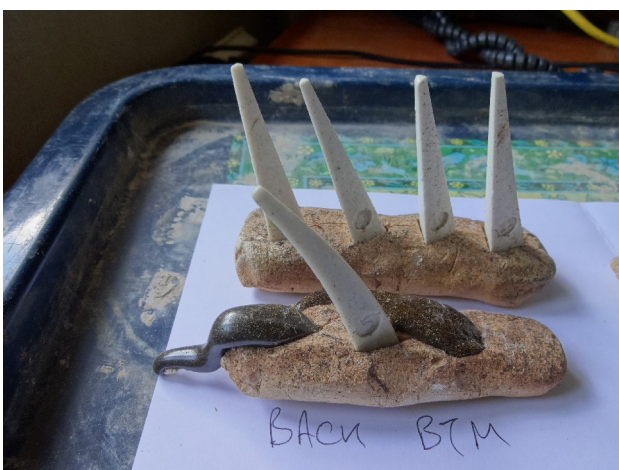
Back Btm shows cones 06/2 collapsed at front with cone 5 having slight sag. Cones 8/9/10/11 having no movement.

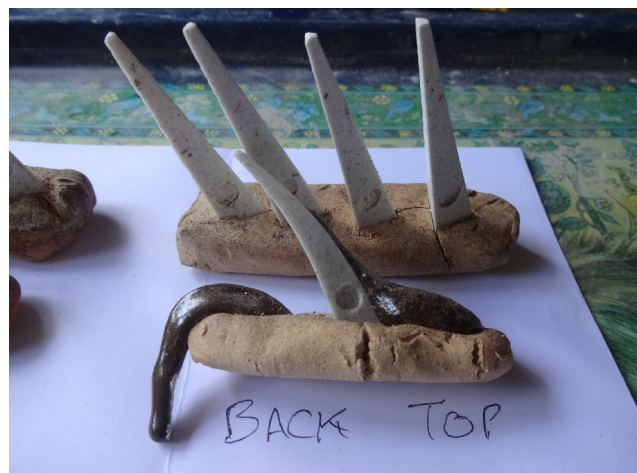
Back Top shows cones 06/2 collapsed at front with cone 5 having slight sag. Cones 8/9/10/11 having no movement.

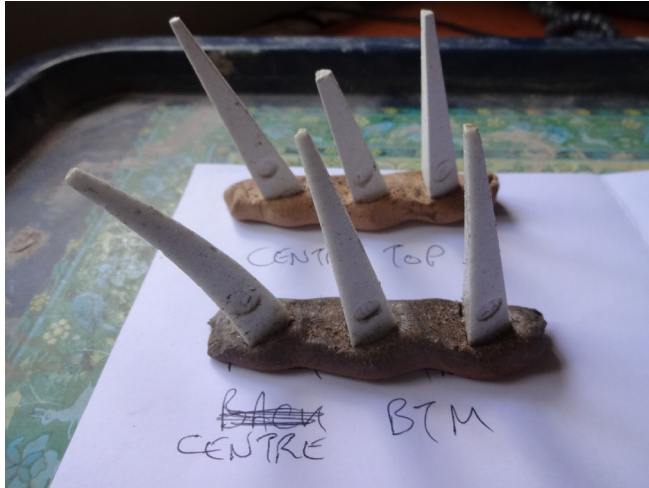
On striking the kiln it was found that the no 8 cone in the centre stack btm had started to sag, though there was no movement in the top centre cones. The kiln therefore was hotter by up to 70 deg C at the bottom of the kiln at the door and in the centre, even though we had attempted to balance out the temperature.

Centre Top at back shows cones 9/10/11 no movement
Centre Btm shows cone 9 with slight sag and 10/11 no movement.

Also it can be seen that the clay cone holder, being the same in both cases, has matured more in the Centre Btm set.
